## INFLUENCE OF THE ANTHROPIC FACTOR OVER THE MODIFICATION OF GEOMETRIC AND HYDRAULIC ELEMENTS OF THE DRAINING NETWORK OF THE ROTOPĂNEȘTI-RĂDĂȘENI-FÂNTÂNA MARE SYSTEM, SUCEAVA COUNTY

Oprea RADU ., F. FILIPOV

University of Agricultural Sciences and Veterinary Medicine, Mihail Sadoveanu Street, 3, Iasi  
E-mail: [opricaradu@yahoo.com](mailto:opricaradu@yahoo.com)

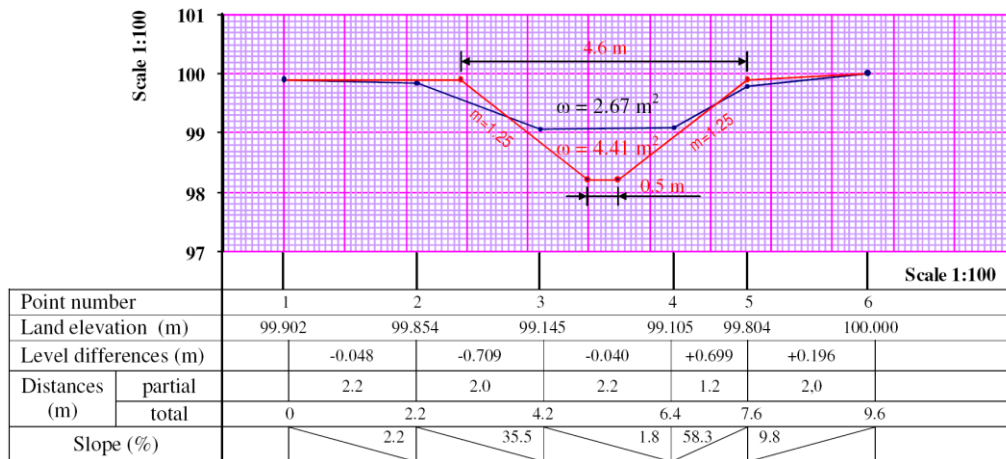
The CC<sub>1</sub> ring canal, at approximately 700 m downstream from its end, initially featured the following geometric and hydraulic characteristics: average depth 1.73 m, width at bottom 0.50 m, canal light 4.60 m, slope coefficient 1.25, and canal sectional area of 4.41 m<sup>2</sup> (figure 2). The measurements on the average transversal sections carried out in the area in 2012, on a 100 m length at every 25 m, reveal an increase in canal light of a mean value of 0.80 m, an increase in the width at bottom of 1.70 m and a reduction in depth of circa 1.00 m. These changes are due to both bank erosion and canal clogging caused by grazing on the canal section and repeated animal crossing, especially that of cattle, adjacent areas being used in summer for cattle grazing and in the rest of the year for sheep grazing. The bank erosion and bottom clogging caused by repetitive and uncontrolled animal crossing through areas unfitted with proper crossings is evident by the reduced flow sections in that sector of the canal, showing values between 2.27 and 2.97 m<sup>2</sup>, the average flow section being 2.67 m<sup>2</sup>, by approximately 40% less than the initial flow section value (figure 2).

Figure 2: Cross section in the CC<sub>1</sub> belt channel, 700 m downstream from the end of the channel, on its completion and in 2012

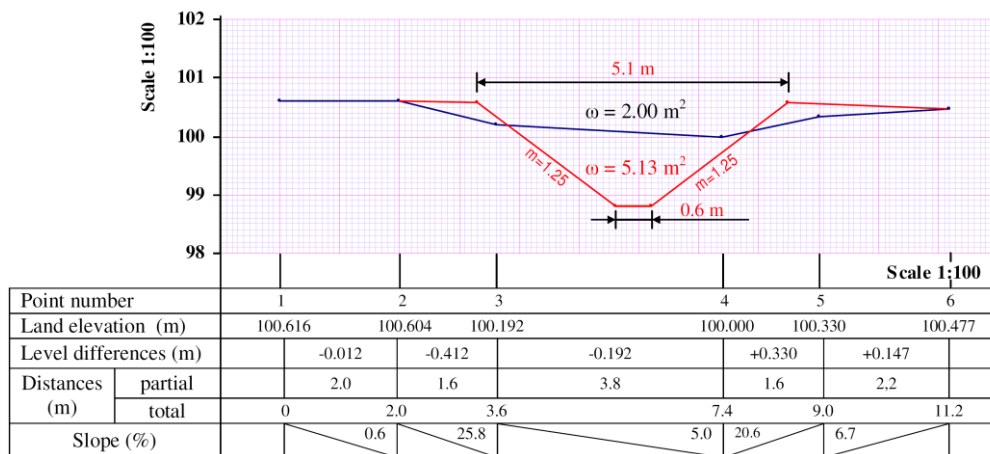
At approximately 1800 m from the upriver end, the measured geometric and hydraulic characteristics were: depth of the canal 1.80 m, width at bottom 0.60 m, canal light of 5.10 m, slope coefficient 1.25 and flow section 5.13 m<sup>2</sup> (figure 3). Following 32 years of exploitation, measurements revealed a canal clogging of some 1.43 m and a flow section of 2.00 m<sup>2</sup>, the latter having diminished by 61% by comparison to the as-built value. Also in this transversal section, a significant enlargement of the width at bottom was observed, from an initial 0.60 m to 3.80 m, as well as an increase in the canal light, from 5.10 m to 7.00 m.

Figure 3: Cross section in the  $CC_1$  belt channel, 1800 m downstream from the end of the channel, on its completion and in 2012

On the 100 m sector upstream from the obstructed culvert a 0.14% counter-slope is maintained, fact that causes, during times of torrential rain, as well as at the spring melt, the water to flow towards the upstream end of the CC<sub>1</sub> canal, overflowing at some 250 m, upstream from the obstructed culvert, in an area where the flow section measures the least value of 2.00 m<sup>2</sup>, section shown in figure 3.

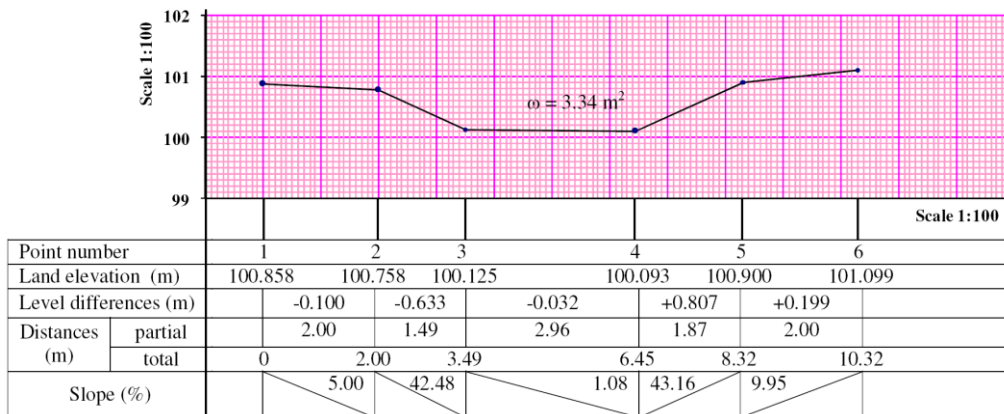
On the 100 m ring canal portion length, section located at the limit of the pasture, at 2000 m from the upriver end, the mean value of the flow section measured every 25 m was 3.34 m<sup>2</sup> (figure 4), the values recorded being in-between 2.72 m<sup>2</sup> and 3.89 m<sup>2</sup>. The great

difference in the flow section, that of  $1.17 \text{ m}^2$ , recorded in transversal sections spaced 25 m apart, verify once more the bank erosion and canal clogging caused by repeated and uncontrolled animal crossing over the section of the canal, the area under monitoring being located in the animal return from grazing path.

Figure 4: The middle section of the channel  $CC_1$ , the length of 100 m, blocked upstream of the culvert

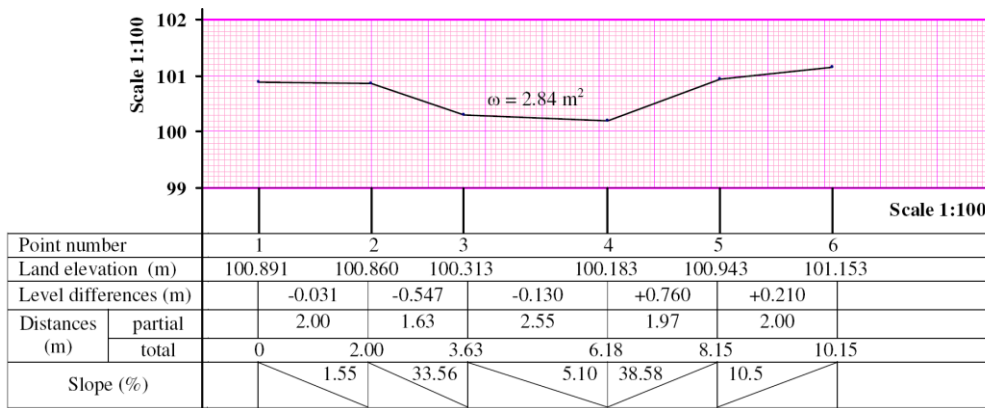
At the transversal profile drafted upstream from the culvert, located at the demarcation line between the pasture and the area used as agricultural land and hayfield, the flow section is  $2.84 \text{ m}^2$  (figure 5). The squeezing in the canal flow section is caused by both water-carried deposits, and by dumping household waste and vegetal debris nearby culverts, the aforementioned activities causing, over time, the complete clogging of the tube section of the culvert (figure 6).

Figure 5: Transversal section through the CC<sub>1</sub> canal, upstream, beside the blocked culvert

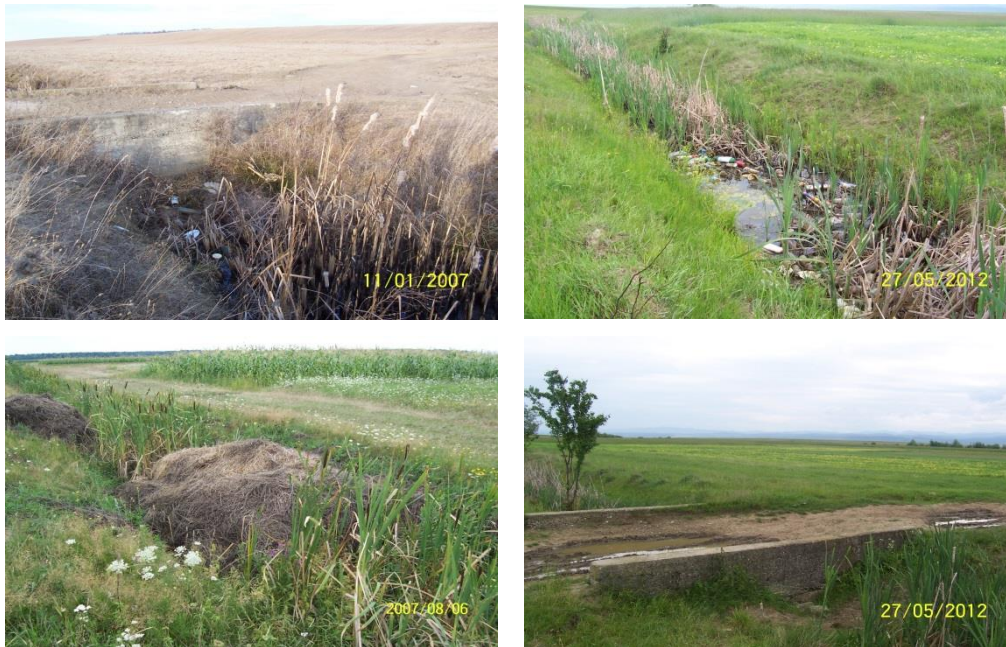
Figure 6: Clogged culvert showing vegetal and household residue within the canals

The depositing of household residue, of vegetal residue, and of various packaging materials into the canals, generally nearby culverts accelerates the process of clogging and blocking.

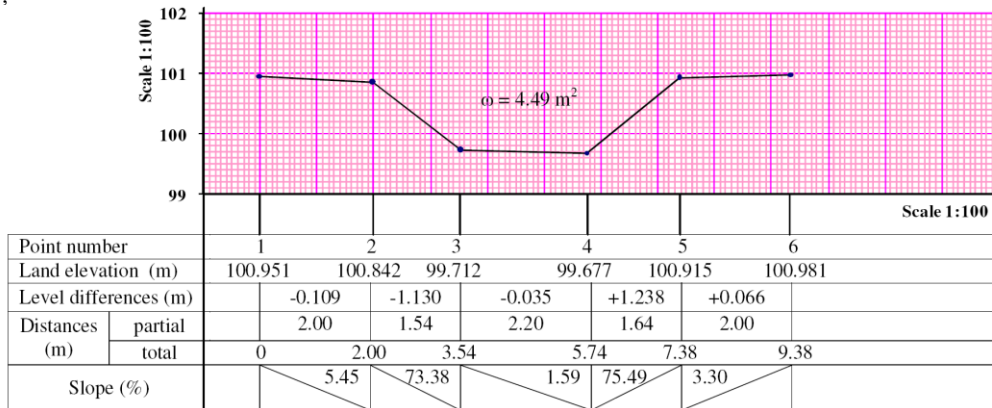
The mean value of the flow section on a 100 m length of the canal, measured at every 25 m, upstream from the clogged culvert, where the land use is agricultural and hayfield, was about 4.49 m<sup>2</sup> (figure 7), recording values that soar from 3.75 m<sup>2</sup> nearby the clogged culvert (figure 8), to 5.09 m<sup>2</sup> at a point located 100 m downstream from the culvert, larger by approximately 1.00 m<sup>2</sup> than the one recorded upstream. Also, the recorded canal flow section nearby culvert and downstream, was greater by some 1.00 m<sup>2</sup> than the one recorded upstream from culvert section, the latter section being only partially clogged at its upstream end.

Figure 7: The middle section of the channel CC<sub>1</sub>, the length of 100 m in the downstream of the culvert blocked

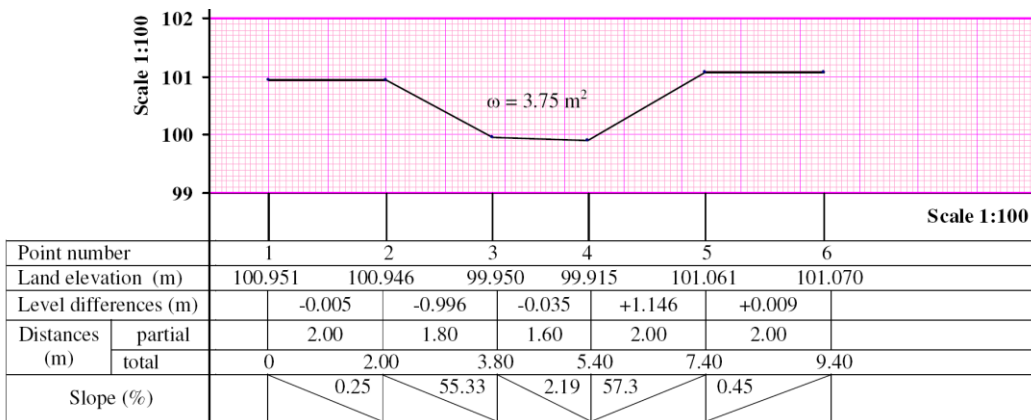
Figure 8: Transversal section through the CC<sub>1</sub> canal, downstream, nearby the clogged culvert

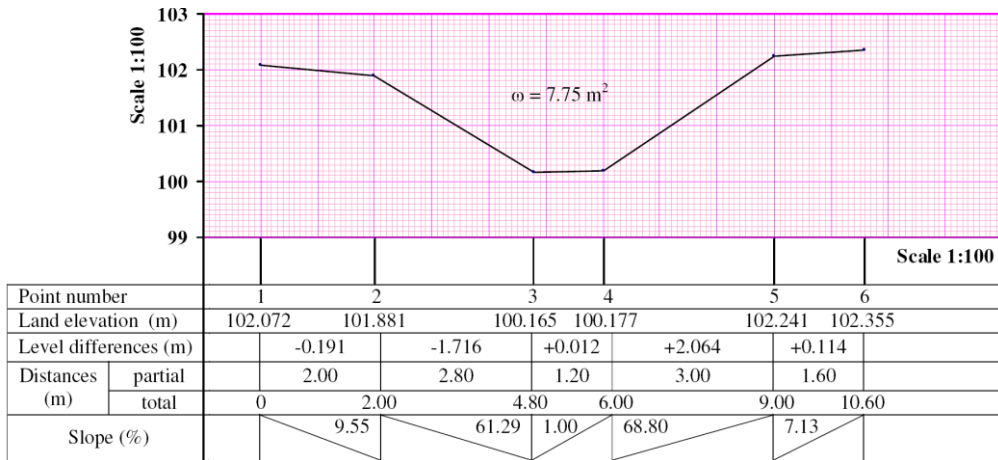
On the section of the canal that serves the areas used as agricultural land and hayfield, the slow section is getting generally enlarged as we move downstream. At the transversal profile made at 400 m, downstream from the clogged culvert, we noticed that the canal constructive features were modified to a lesser extent, the flow section being  $7.75 \text{ m}^2$  (figure 9), fact that secures the transit of collected waters towards the main collector canal, the Şomuzel.

Figure 9: The cross-section of the channel CC<sub>1</sub>, 400 meters downstream of the culvert blocked

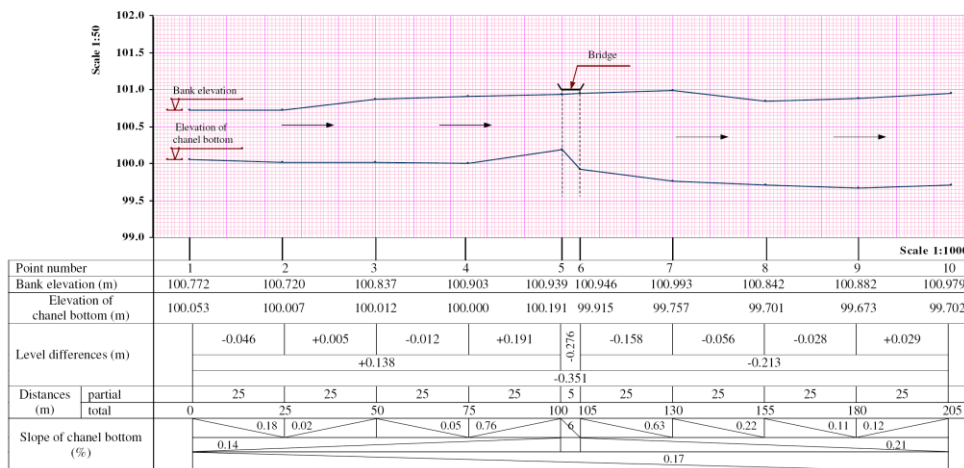
The clogging of the bottom of the canal and obstruction of the culvert lead to a change in the canal longitudinal slope. At the longitudinal profiling carried out on a 200 m length at every 25 m, (100 m upstream and 100 m downstream the obstructed culvert), one notices different longitudinal slope values and the creation of a counter-slope, with values in- between 0.02% and 0.76% (figure 10).

By analyzing the elevation heights on the bottom of the ring canal (figure 10), one notices that beside the culvert and downstream, the elevation was lesser by 0.30 m, by comparison to the one recorded nearby the culvert and upstream, the latter section being only partially clogged at its downstream end.

Figure 10: Longitudinal section CC1 channel upstream and downstream of the culvert blocked

By taking into consideration the elevation height on the bottom of the canal located upstream from the culvert, where the section of the tube is completely obstructed, there results that the clogging also took place on the 100 m portion downstream from the culvert, due to dumping household waste and vegetal debris into the canal, to the sedimentation of deposits carried by the water collected into the canal from the pasture areas, at a time when the culvert was still securing the transit of collected water flow.

Besides, even to this day, on the 100 m section and downstream, one notices the occurrence of a 0.12% counter-slope that causes the water to stale, and also the incidence of water vegetation, fact that stimulates the sedimentation of deposits and the clogging. On the overall 200 m longitudinal section length, a water flowing slope of 0.17% was determined, sufficient to secure the transit of collected water and its spilling into the main collector canal Şomuzel, had not the culvert acted as a dam.

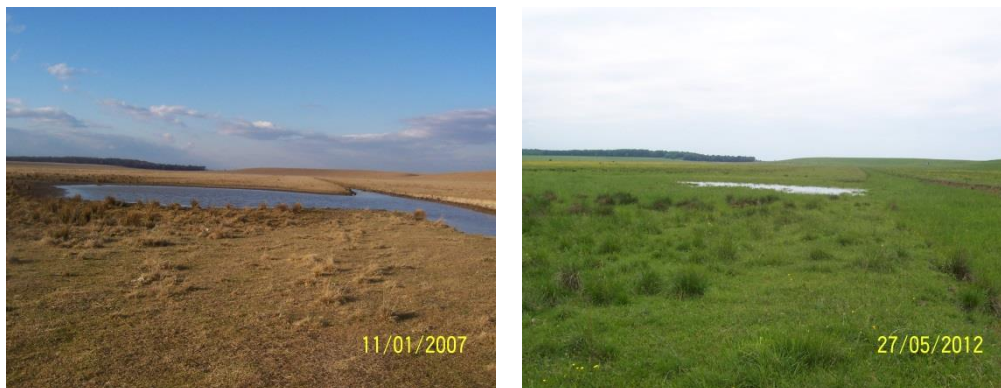
The collected water overflow and the flooding of nearby fields causes a prolongation of excess humidity, the incidence of water vegetation and a disruption in the functioning of the desiccation- drainage network.

The clogging of the canal and the water overflow upstream from the culvert have caused the occurrence of a water surface whose stretch varies according to the season and the recorded rainfall or snowfall (figure 11), whereas throughout times of heavy rain, the water overflow is being collected in the main collector canal Şomuzel, whose path in the area is nearly parallel to the CC<sub>1</sub> ring canal, causing an increase in the bank erosion of the main collector canal (figure 12).

Figure 11: Water overflowing the canal and the subsequently formed pond

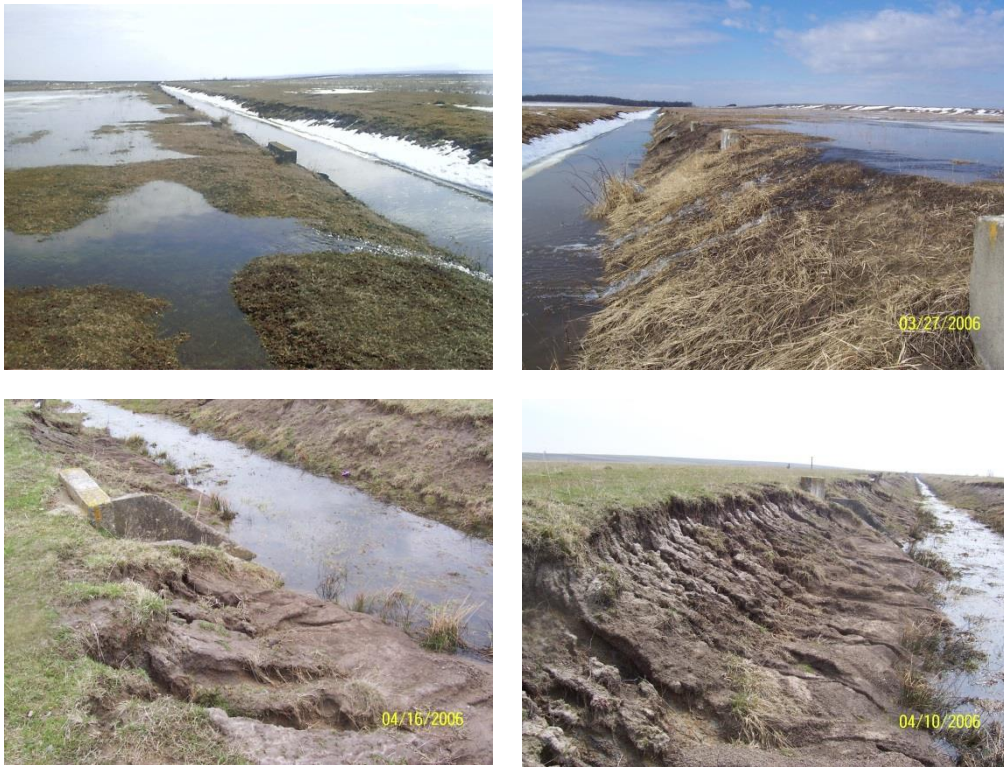
Figure 12: Taking poured water channel "Şomuzel"
