STUDIES REGARDING THE IRRIGATION SYSTEM FROM THE GREAT BRĂILA ISLAND – ROMANIA

I. MOCANU, Cătălina Ionela PREPELIȚĂ(POPOVICI), D. BUCUR

The objective of the paper is to analyze the technical solutions for the rehabilitation of irrigation systems applied in the Big Island of Brăila in recent years.

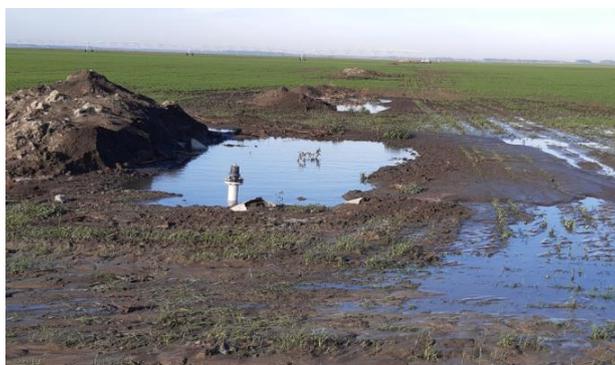
The network of buried pipes suffered damage consisting mainly of breaking, tearing and decommissioning of all hydrants.

In all the existing hydrants, the rupture of the hydrants itself was found, and in some hydrants, the upper branch of the underground roofs was also damaged.

Photo 1 Hydrant network

- restoring the functionality of the existing antennas by restoring the pipe sections in the area of the broken hydrants (photo 1);

Restoration of pipe sections with broken hydrants 241 pieces of which 161 rebuilt by replacement with HDPE nozzles and 80 pieces. by plugging with blind flange.

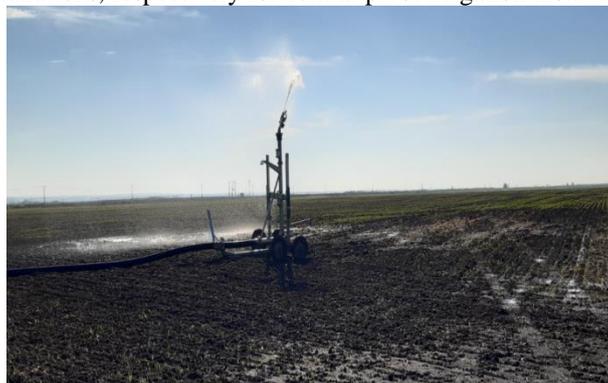
Photo 2 Irrigation system with drum and hose.

- achieving the conditions for the use of modern irrigation equipment provided by OUI IMB (Organization of Individual Water Users from the Big Island of Brăila) for drum and hose irrigation installations, respectively for central pivot irrigation installations (photo 2).

New Dn hydrants (nominal size) 100 mm were purchased and used for irrigation water supply of drum and hose sprinkler irrigation systems.

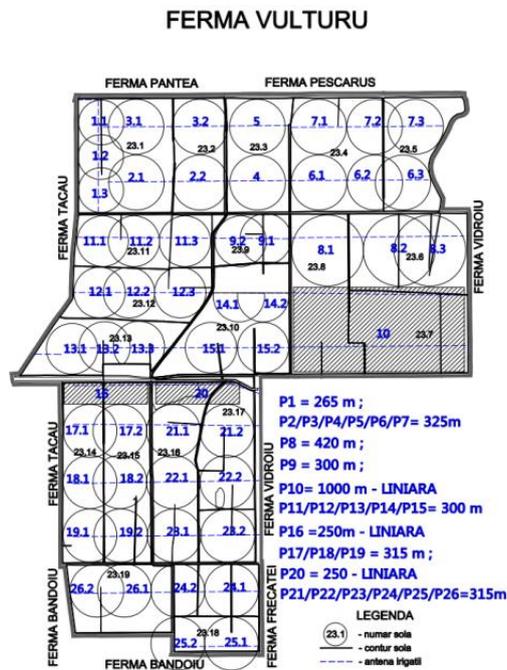
Photo 3 Pivot layout, Vultur Farm

➤ New hydrants Dn 150 mm, in number of 45 pcs. were used to supply central pivot irrigation systems.

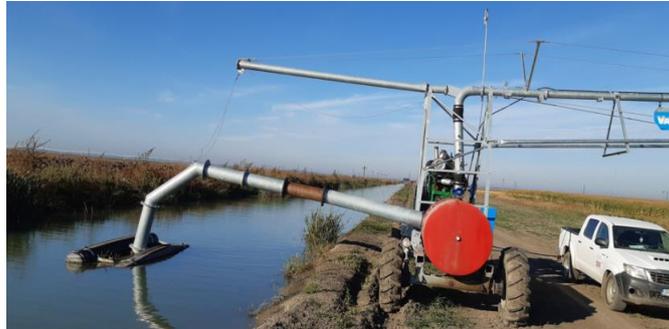
Photo 4 Linear irrigation system with floating pontoon

At the Vultur farm, an area of 200 ha is irrigated with a linear installation of 1000 m, supplied with water from the canal, with the help of a floating pontoon (photo 4).

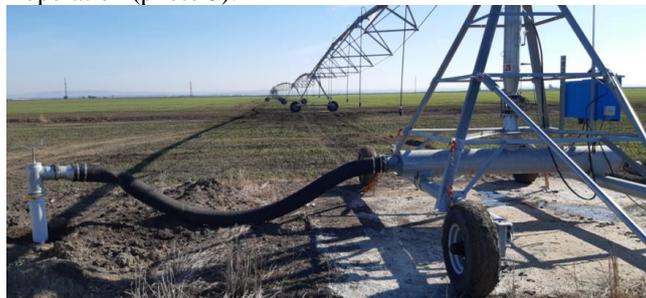
Photo 5 Pivot irrigation system connected to hydrant

The pivots are anchored in simple concrete anchoring masses, which gives them a proper stability in operation (photo 5).

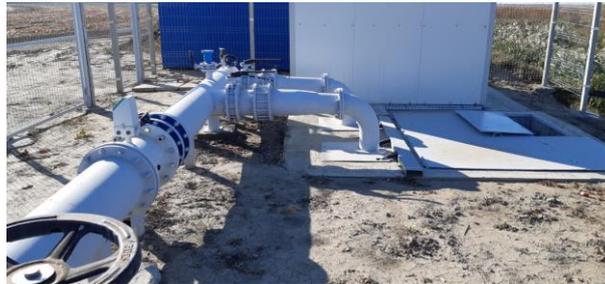
Photo 6 Realization of the annex constructions for concrete tank type stations

For access to the tank, a frame with a lid fixed in the concrete slab was provided by means of rods welded by it (photo 6).

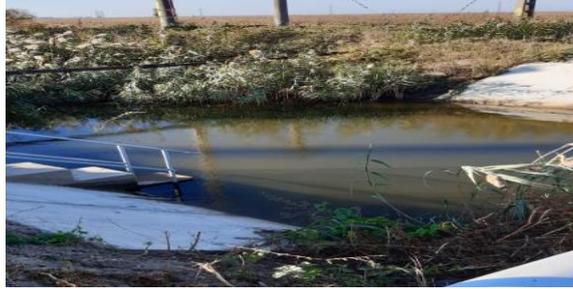
Photo 7 Protecting the canal in the suction area

The canal was protected in the suction area with a simple concrete wall 10 cm thick, 3.00 m upstream and 3.00 m downstream of the suction pipes. The pier was made on the side of the station, as well as on the bottom of the canal and on the opposite slope, up to the upper level of the water in the canal (photo 7).

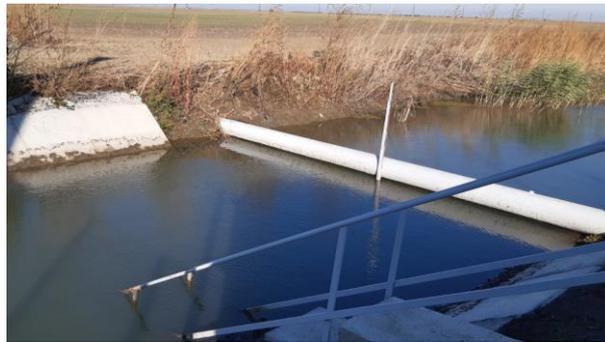
Photo 8 Crossing the pipe to the antenna

In order to support the discharge pipe at the crossing of the canal, two reinforced concrete pillars were provided to support it. The pillars have a section of 30x30 cm and are embedded in foundations of 60x60 cm, laid at the depth of frost in the area (approx. 1.00 m), photo 8.

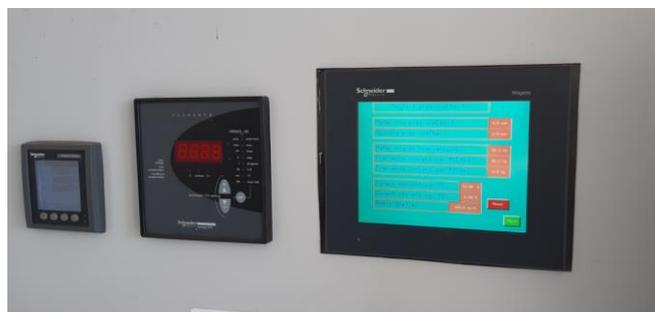
Photo 9 Pump control panel display

The display of the panel shows the status of the pumps (on / off / failure), all their operating parameters, the number of operating pivots on each antenna, the operating time and the pumped water flow (photo 9).
