## ASSESSMENT OF THE URBAN LANDSCAPE OF PETROȘANI MUNICIPALITY AND THE IMPACT OF ABANDONED BUILDINGS ON IT

Liliana NEGOE<sup>1</sup>, Izabela-Maria APOSTU<sup>1</sup>, F. FAUR<sup>1</sup>, Maria LAZĂR<sup>1</sup>

<sup>1</sup>University of Petroșani, Faculty of Mining

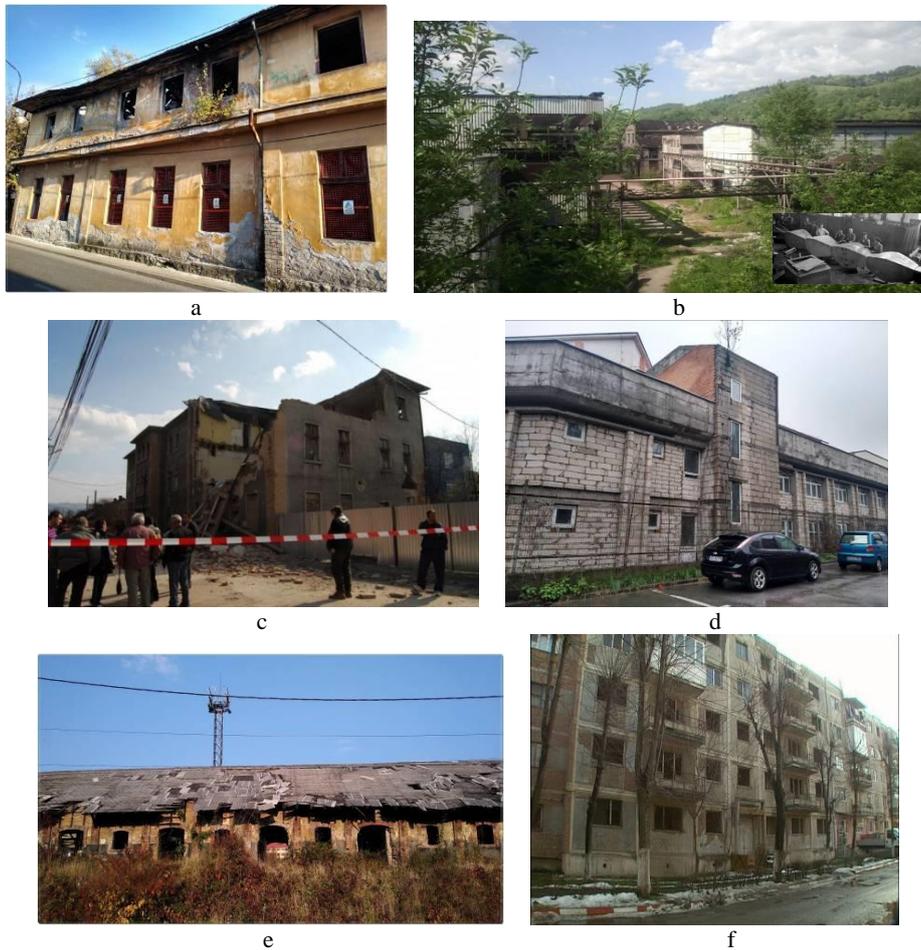
Figure 3. Abandoned buildings from Petroșani municipality

**C1.** Former Military Unit 01032 (private property, area 1) - constructed in the central area, is ruined on the day that passes, without the authorities being able to intervene (Figure 3a). In the building that has an area of 335.44 m<sup>2</sup>, as well as an interior courtyard of 279.27 m<sup>2</sup>, the City Hall intended to move the Community Public Service for the Evidence of Persons.

In addition to the danger it poses for passers-by, periodically pieces of plaster, bricks and tiles falling from the building, there is also the danger of arson and its propagation in the neighboring buildings (in the last 5 years, firefighters were forced to intervene 4 times in order to extinguish fires caused by those who sheltered in these ruins) and the dejections and household waste generated transformed the area into an outbreak of infection.

**C2.** Petroșani Central Workshops/IUMP/UMIROM/GEROM (private property, area 3) - at the north entrance in Petroșani, between Dărănești and Petroșani Rail Station, we are greeted by the ruins of what was once an important mining equipment company in Romania (Figure 3b). Beyond the importance on the industrial and socio-economic level (here being employed more than 3,500 people at one time), some of the now abandoned buildings are loaded with history, here being cast the famous Infinity Column, a masterpiece of the famous sculptor Constantine Brancuși.

**C3.** CONSMIN building (private property, area 3) - as the company name suggests, it had as object of activity mining constructions and, as expected with the restructuring of the activities in this sector, the company went bankrupt. The building located on Mihai Eminescu

street was abandoned, at present being in a state of ruin and constituting a real public danger for passers-by (by collapsing of constructive elements) (Figure 3c).

**C4.** Student Cultural House (the “new” establishment, property of Ministry of Youth and Sport - National Youth Authority (ANT), area 1) - the construction started 27 years ago, in the autumn of 1992. According to the construction plan, at the time of commissioning, the building was to have, among other things, a 485-seat showroom, a discotheque, a restaurant, 12 studios for guests, rehearsal rooms for artistic formations, as well as numerous other annexes. The building works were abandoned in 2006 (Figure 3d). The University of Petroșani wants to take over the building, conditioned by the possibility of financing the project from European funds (at a first analysis we are talking about 3 million Euros).

**C5.** CFR (Romanian Rail Ways) Deposits (CFR patrimony, area 3) - located at the north exit from Petroșani Rail Station, on the left side on the direction towards Simeria, these deposits have not been used since the early 90s (Figure 3e). For a long time in these buildings, people from Colony District found their shelter turning them into real outbreaks of infection

and causing some small fires. At present the structure of resistance is severely affected, the roof presenting an imminent danger of collapse, was abandoned by people, being "taken over" by homeless animals.

**C6.** Apartment building (public domain, area 4) – located in Aeroport (Airport) District. After the restructuring process started in 1996 (still unfinished), due to population migration, entire apartment buildings were abandoned (Figure 3f). Beyond the danger represented by the plaster pieces that fall out of the building, by the unsightly appearance, this represents a real danger for children in the area who use it as a playground.

For this reason, part of the abandoned buildings (C1, C3 and C5) must be removed from the urban landscape/environment of Petroșani municipality (demolished, and the land thus released made available for other purposes), while the rest must enter as soon as possible in capital repairs and rehabilitation works.
