**PERFORMANCES AND BOUNDS OF THE ENGINEERING WORKS
FOR CONSERVING, CLOSING AND ECOLOGICALLY REHABILITATING
THE DECANTATION PONDS IN THE MINING INDUSTRY
IN THE CARAS-SEVERIN COUNTY**

Irina MARINICA, I. BORZA

*Agricultural and Veterinary University of the Banat, Timisoara, Romania
Corresponding author: Irina Marinica, e-mail irimihailescu@yahoo.com*

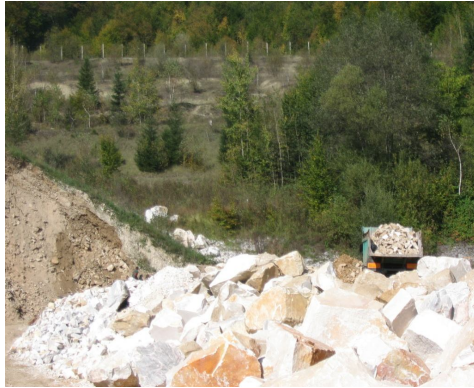
Fig.1 - The pond Porcul-Ruschita

At the pond *Bocsa I*, the sentinel channels that were built with stone riprap became clogged and portions of several meters have been vandalized. At the pond *Porcu - Ruschita*, on the slope of the priming embankment, tail rocks from the marble quarry Ruschita have been laid down and the road vehicles created an access road in the area where the undercrossing channel (with circular cross-section) was extended (with trapezoidal cross-section). This could pose structural trouble.

At the upward mouth of the channel, which undercrosses the Porcului Valley steel rails (girders) have been placed in order to stop, the floating matter, but they are stolen now.

The network of piezometers installed to monitor the hydrostatic level was also pillaged.

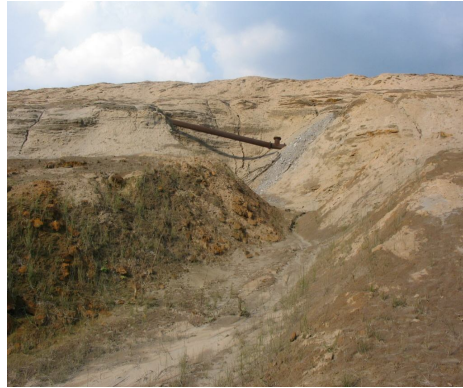
Fig.2 - Ravines at the pond Sasca Montana

It is a pond with particular stability problems. During its operational period it slid twice (1991, 1992) covering about 2 ha of agricultural fertile land located in the meadow of the Nera river. Considered and designed as a slope pond, it is in fact, based on the land morphology, a valley pond because it is located on a valley with a dried watercourse. As such, based on its construction, a watercourse-undercrossing channel is missing. When precipitations are high, the reverse probes do not behave as expected and the pond slides. The provisional solution - also being currently used - is to make a sentinel channel on the western bank which to overtake the feeder stream. Being a dug channel not embedded in concrete, accentuated vertical erosion occurs. Deep ravine emergence on the edge of the pond is frequent.
