INTEGRATING 3D LASER SCANNING & UAV TECHNIQUES FOR ROAD BRIDGE INSPECTION

This paper presents a **case study** of a concrete bridge along the Athens–Corinth highway. The objective was to create a **digital twin (DT)** of the structure by integrating TLS and UAV photogrammetric data. The digital twin offers accurate assessment of the bridge's condition, detection of pathology and supports maintenance planning.

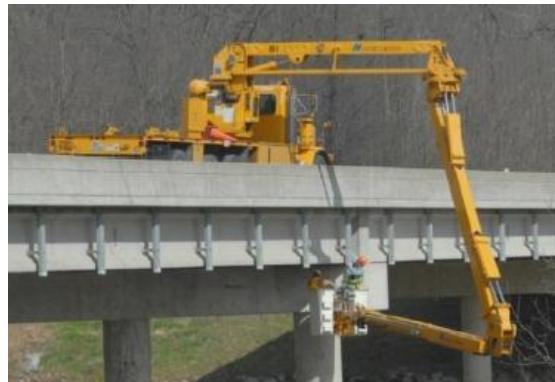
Figure 1. Bridge inspection with optical methods

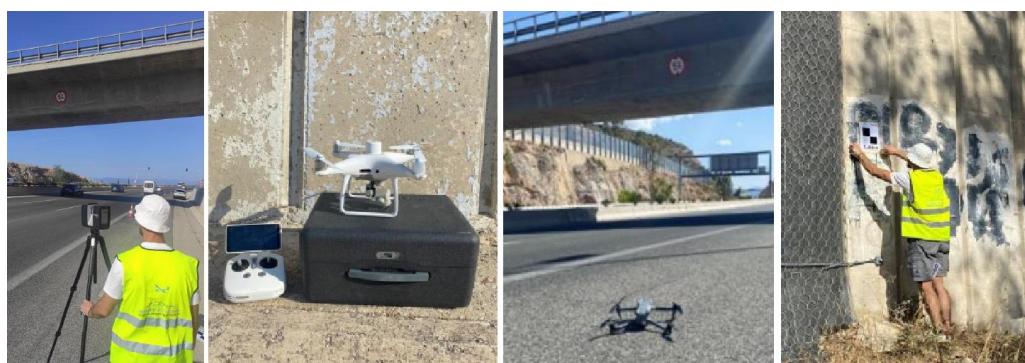
Figure 3. The equipment used during the measurements (a. Faro Focus Premium, b. DJI Phantom 4 RTK, c. DJI Mavic Air 3, d. Checkerboard Targets)

The successful creation of a high precision Digital Twin requires the integration of various equipment (Figure 3):

a) Terrestrial Laser Scanner: The FARO Focus Premium [0] was used. It has a high accuracy geometric output, which is essential for preparing a precise DT. It has a scanning range of 150 m. The measurement error is 2 mm at 10 m and 3.5 mm at 25 m, which makes it ideal for the required geometry. Moreover, it supports High Dynamic Range (HDR) imaging, providing realistic colorization for the point cloud.

b) UAV DJI Phantom 4 RTK [0]: It was deployed for peripheral and upper images. It has a camera of 20 Mpixels.

c) UAV DJI Mavic Air 3 [0]: A second drone was required to address specific viewing angle limitations inherent to photogrammetry, particularly for the bridge bottom part. It features a high resolution 48 Mpixels camera with both wide-angle and telephoto lenses. Crucially, its gimbal rotates +60° on the vertical axis, allowing the necessary high angle images of the bridge's underside, a traditionally difficult area to inspect.

d) Checkerboard Targets: Twenty numbered checkerboard targets (25 x 25cm) were evenly placed across the structure. These served as essential ground control points (GCPs), necessary for three purposes: ensuring highly accurate registration (alignment) of the 18 TLS scans, linking the aerial photogrammetric data to the TLS coordinate system and validating the final model's geometric integrity.

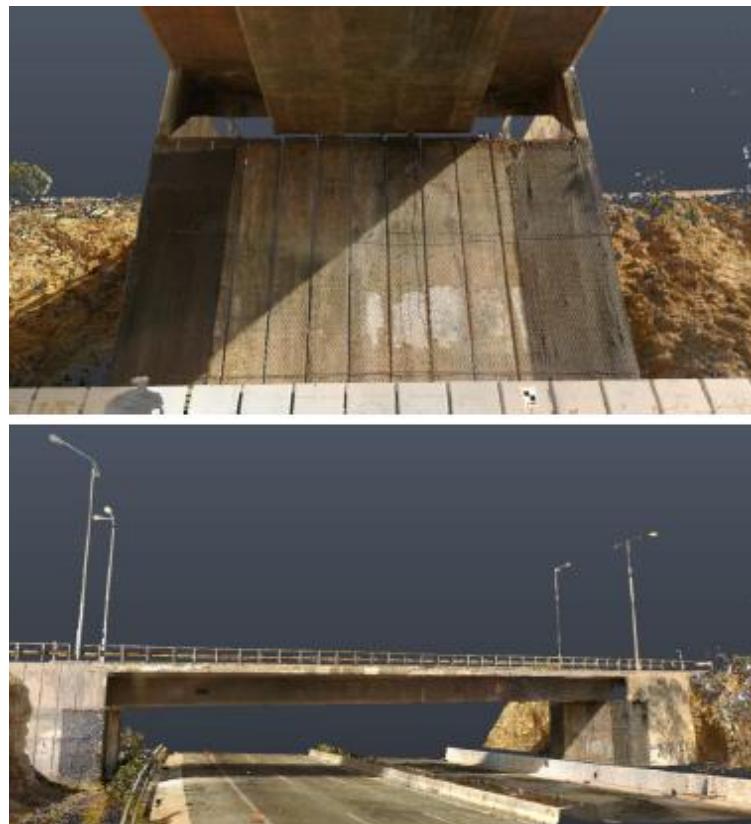
Figure 4. Instances of the final cleaned 3d point cloud

Autodesk Recap's user-friendly environment facilitates quick manipulation and visualization of the dense point cloud, making manual noise removal faster and more precise than relying solely on automated filtering. The final, clean point cloud was then converted to the native .rcp format for seamless integration with other Autodesk tools. The output of this stage is the final geometrically purified TLS point cloud, ready for fusion with the aerial data (Figure 4).

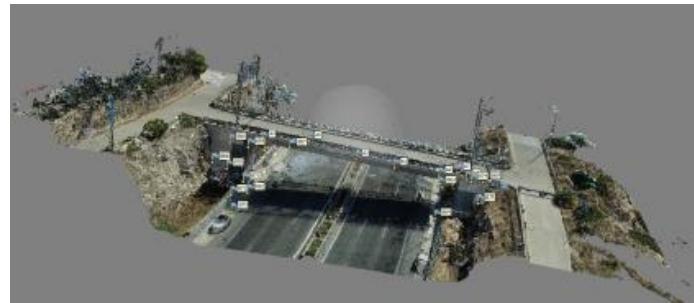
Figure 5. Point cloud from the photogrammetric procedure

The 2038 UAV images (from the Phantom 4 RTK and Mavic Air 3) were processed in Agisoft Metashape (Figure 5). The subsequent critical step was the geometric synchronization of the photogrammetric data with the high-accuracy TLS data. The measured checkerboard markers were introduced into the project and assigned the coordinates defined by the TLS local system. The different clouds were transformed, bringing the aerial data into the stable, millimetrically accurate coordinate system established by the laser scanner. The two synchronized clouds were then combined.

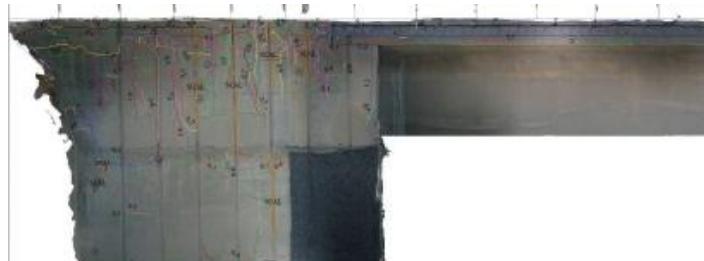
Figure 7. Digitized cracks and pathology on the orthomosaic of the bridge

The crack features are digitized and then dimensioned using the software's measuring tool. The measurement of the crack width is taken antidiagonally across the widest point, focusing on the dark pixel border to delineate the crack edges. This stage leads in the preparation of accurate drawings of the bridge's pathology distribution (Figure 7).

The final inspection documentation includes highly accurate representations of all structural faces (Abutment Views, Cross Sections, North and South Elevation Views, Bottom View). The orthomosaics clearly show the location, the extent and measured dimensions of the digitized pathologies across the structural elements of the bridge.
