THE INFLUENCE OF AGRICULTURAL ACTIVITIES ON THE QUALITY OF GROUNDWATER IN MEHEDINTI COUNTY

Virginia-Simona MARIAN (ILIE)¹, Laura ŞMULEAC², Cristina TULBURE²

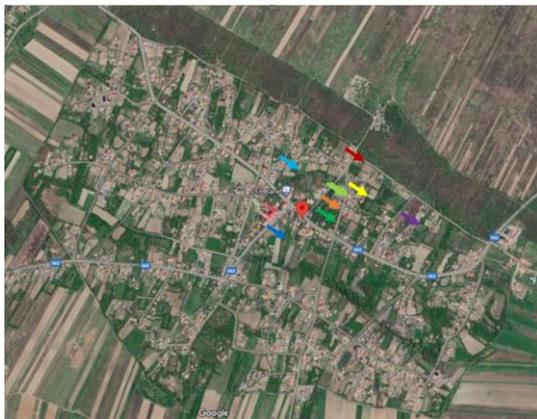
The locations of the wells in Devesel commune

Fig. 1. Location of the wells

In zone 1 D (Devesel commune) we took water samples from the wells of 4 families, having a well in the yard, a clayey area (which we noted well 1, 2, 3, 4), located at a distance of about 200 meters and water samples from 4 wells, located outside the courtyards of the

- ✓ fountain 5 to the hill, Devesel commune cemetery - northern part; sandy area;
- ✓ fountain 6 located in the middle of the village, clayey area;
- ✓ fountain 7 located at the edge of the village, to the east, to the communal dispensary;
- ✓ fountain 8 located at the exit from Devesel commune, towards Jiana commune - southern part, clayey area.

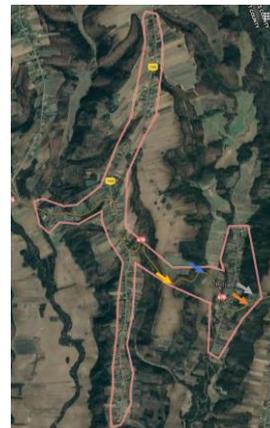
The locations of the wells in Chilia village

In area 2 C (Chilia village) we took water samples from 4 wells located outside the people's yards. Two of the fountains are at a distance of about 200 meters and we noted fountain 1 and fountain 2. And we also took two water samples from two wells located along the road, which we noted :

- ✓ fountain 3, at the edge of Devesel Commune, on the main road to Chilia, west side, sandy area.
- ✓ and fountain 4, also on the edge of Devesel Commune, on the main road to Chilia.

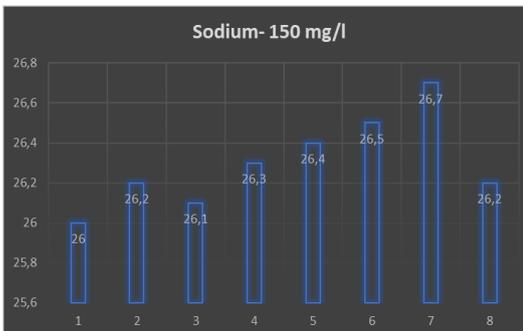
Fig. 8. Values of Sodium in Devesel comune

According to the graphic representations, regarding the quality parameters of the groundwater samples from the rural environment in zone 1 D (Devesel commune), it is found that in no well the maximum allowed concentration of nitrate, nitrite and ammonium is exceeded. In all wells the concentrations of phosphate, potassium, iron, manganese, chloride and sodium ions do not exceed the CMA. There are also no exceedances of the CCO-Mn value, and the pH is within the limits allowed in all 10 wells (figures 2-11).

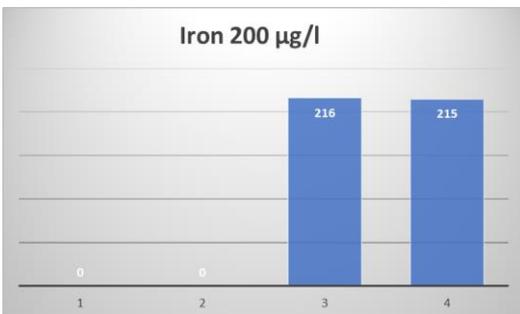
Fig. 18. Values of iron in Chilia village

It is further observed that following the sampling in area 2 C (Chilia village): in wells no. 3 and 4 the nitrate concentration exceeds the maximum allowed limit; the concentration in wells 3 and 4 of nitrite is exceeded; In wells 3 and 4 the chlorides exceed the CMA; there is thus the possibility of water pollution with animal manure; The CMA for phosphate, manganese and sodium ions is not exceeded in any of the wells analyzed; in wells no. 3 and 4 the concentration of ammonium ion exceeds the allowed limit; the iron ion concentration exceeds the limit allowed in wells no. 3 and 4; in wells 3 and 4, the CCO-Mn value exceeds the allowed limit; The pH is within the limits allowed in all 4 wells; in wells 1 and 2, the concentration of potassium ion is within the permissible limits; at wells 3 and 4, the maximum permissible concentration is exceeded (figures 12 - 21).

In zone 2C we found exceedances regarding the maximum allowed concentrations for nitrate, nitrite, ammonium, chloride, CCo-Mn, potassium and iron in wells 3 and 4.
