STUDIES REGARDING THE IRRIGATION SYSTEM FROM THE GREAT BRĂILA ISLAND – ROMANIA

I. MOCANU, Cătălina Ionela PREPELIȚĂ(POPOVICI), D. BUCUR

The objective of the paper is to analyze the technical solutions for the rehabilitation of irrigation systems applied in the Big Island of Brăila in recent years.

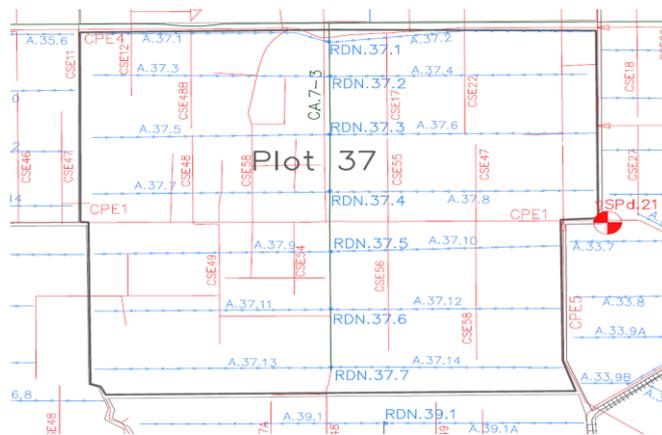
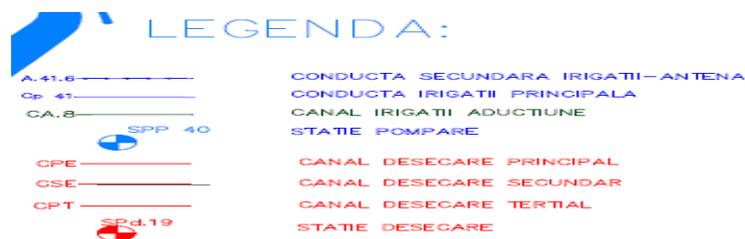
Fig. 4 Hydrotechnical scheme of the Plot arrangement 37

Plot number 37 (figure 4), represents the surface served by a pressure pumping station, owned by the Organization of Irrigation Water Users from the Island of Brăila.

Irrigation plot number 37 is located on the territory of Frecăței commune and serves an area of 1920 ha in the farms - Țăcău, Frecăței, Vulturu and Băndoiu.
